## 2<sup>nd</sup> Investigation And The Repair Task

*Mike Alfrey.*

*For the Rover Car Club of Australia Inc.*

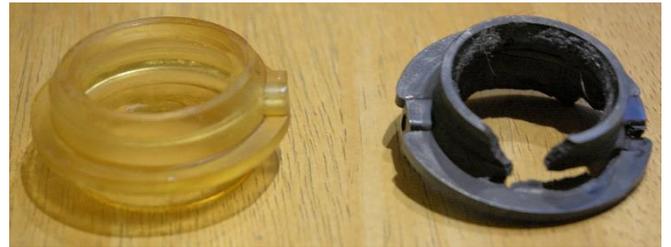
Back under the car, it was a simple matter to unscrew the control rod's ball shank from the bottom of the shift lever and lift the lever away. The pressed steel plate and studs assembly (*Item 9*) was then unbolted. The plate's removal revealed a sad mess that was the remains of the original bushing, refer to *Figure 2*. Comparison with the new bushing revealed that the 1977 Rover P6B featured two side locating pins (*Item 8*), whereas the new bushing was drilled for just one pin. Scott advised that the bushing should be drilled right through to accommodate the second pin. There was also advice that the pins should be installed without grease.

*Figure 2. The new bushing is at left. Note that the new bushing has just one locating lug.*

All components that had been removed were cleaned up and the ball on the lever was polished enthusiastically with Brasso to achieve a smooth surface and get rid of a felt/sealant mess that adhered to it. Once the cleaning was finished, the new bushing (*Item 7*) was drilled through and given a generous smear of Chemlube high temperature Silicone Grease and then the lever was pushed into the bushing. This went quite easily and it was a simple matter to grip the pins with a pair of self-locking pliers and push them home into the ball part of the lever. Once started, the bushing was swivelled until the rounded end of the pin entered the hole in the ball. Then the second pin was pushed into place. It should be noted that the pins are a tight fit in the bushing.

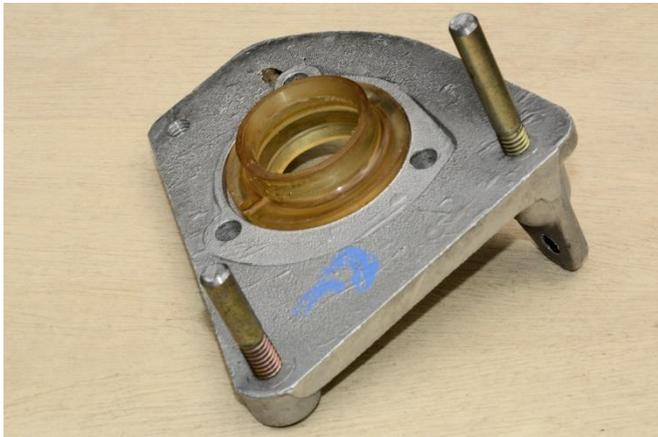
Figure 3. Bottom plate, showing the two guide studs.

Next came the consideration of how one man could hold the base plate and lever assembly in place, while he installed the upper housing assembly. The solution was to have my wife, Sue, give some mechanical assistance. First, though, I cut the heads off two long 5/16" UNC bolts and ground a radius on the shanks. Refer to *Figure 3*. The studs were threaded into the base plate and the assembly held in place from under the car. Then, with the assembly still held in place, Sue clamped a protruding stud shank with self-locking pliers (Vice-grips) so the assembly stayed in place.

Once back in the car, the pliers were used to guide the plate into position so that a short setscrew could be screwed into the rear hole in the plate and nipped up securely. The upper housing assembly (*Item 20*) was slid over the lever and the light assembly. Another long 5/16" UNC bolt was screwed in place, instead of one of the studs. This allowed a degree of movement while the rear setscrew was removed and the second stud screwed in.

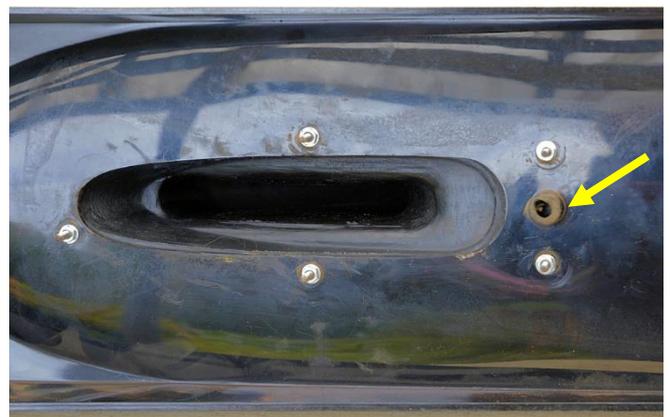
Figure 4. Console viewed from underneath showing the five 3 mm nuts and washers. The screw boss is arrowed.

The original handbrake boot had split in a few places, that meant that the removal of the centre console was made easy by use of a sharp knife and cutting it away from the lever. This made removal of the centre console an easy task. Once the console was turned over, five steel pegs were revealed, these were employed to secure the boot to the console with speed-clips fitted from the underside. Personally, such clips have never been admired very much, that meant another holding method was required, The solution was to use a 3 mm die-nut (from Dormer, UK) to cut a thread on each stud. From there, 3 mm nuts and washers were used to fasten the boot to the console.
